# 360deg electronic transducer

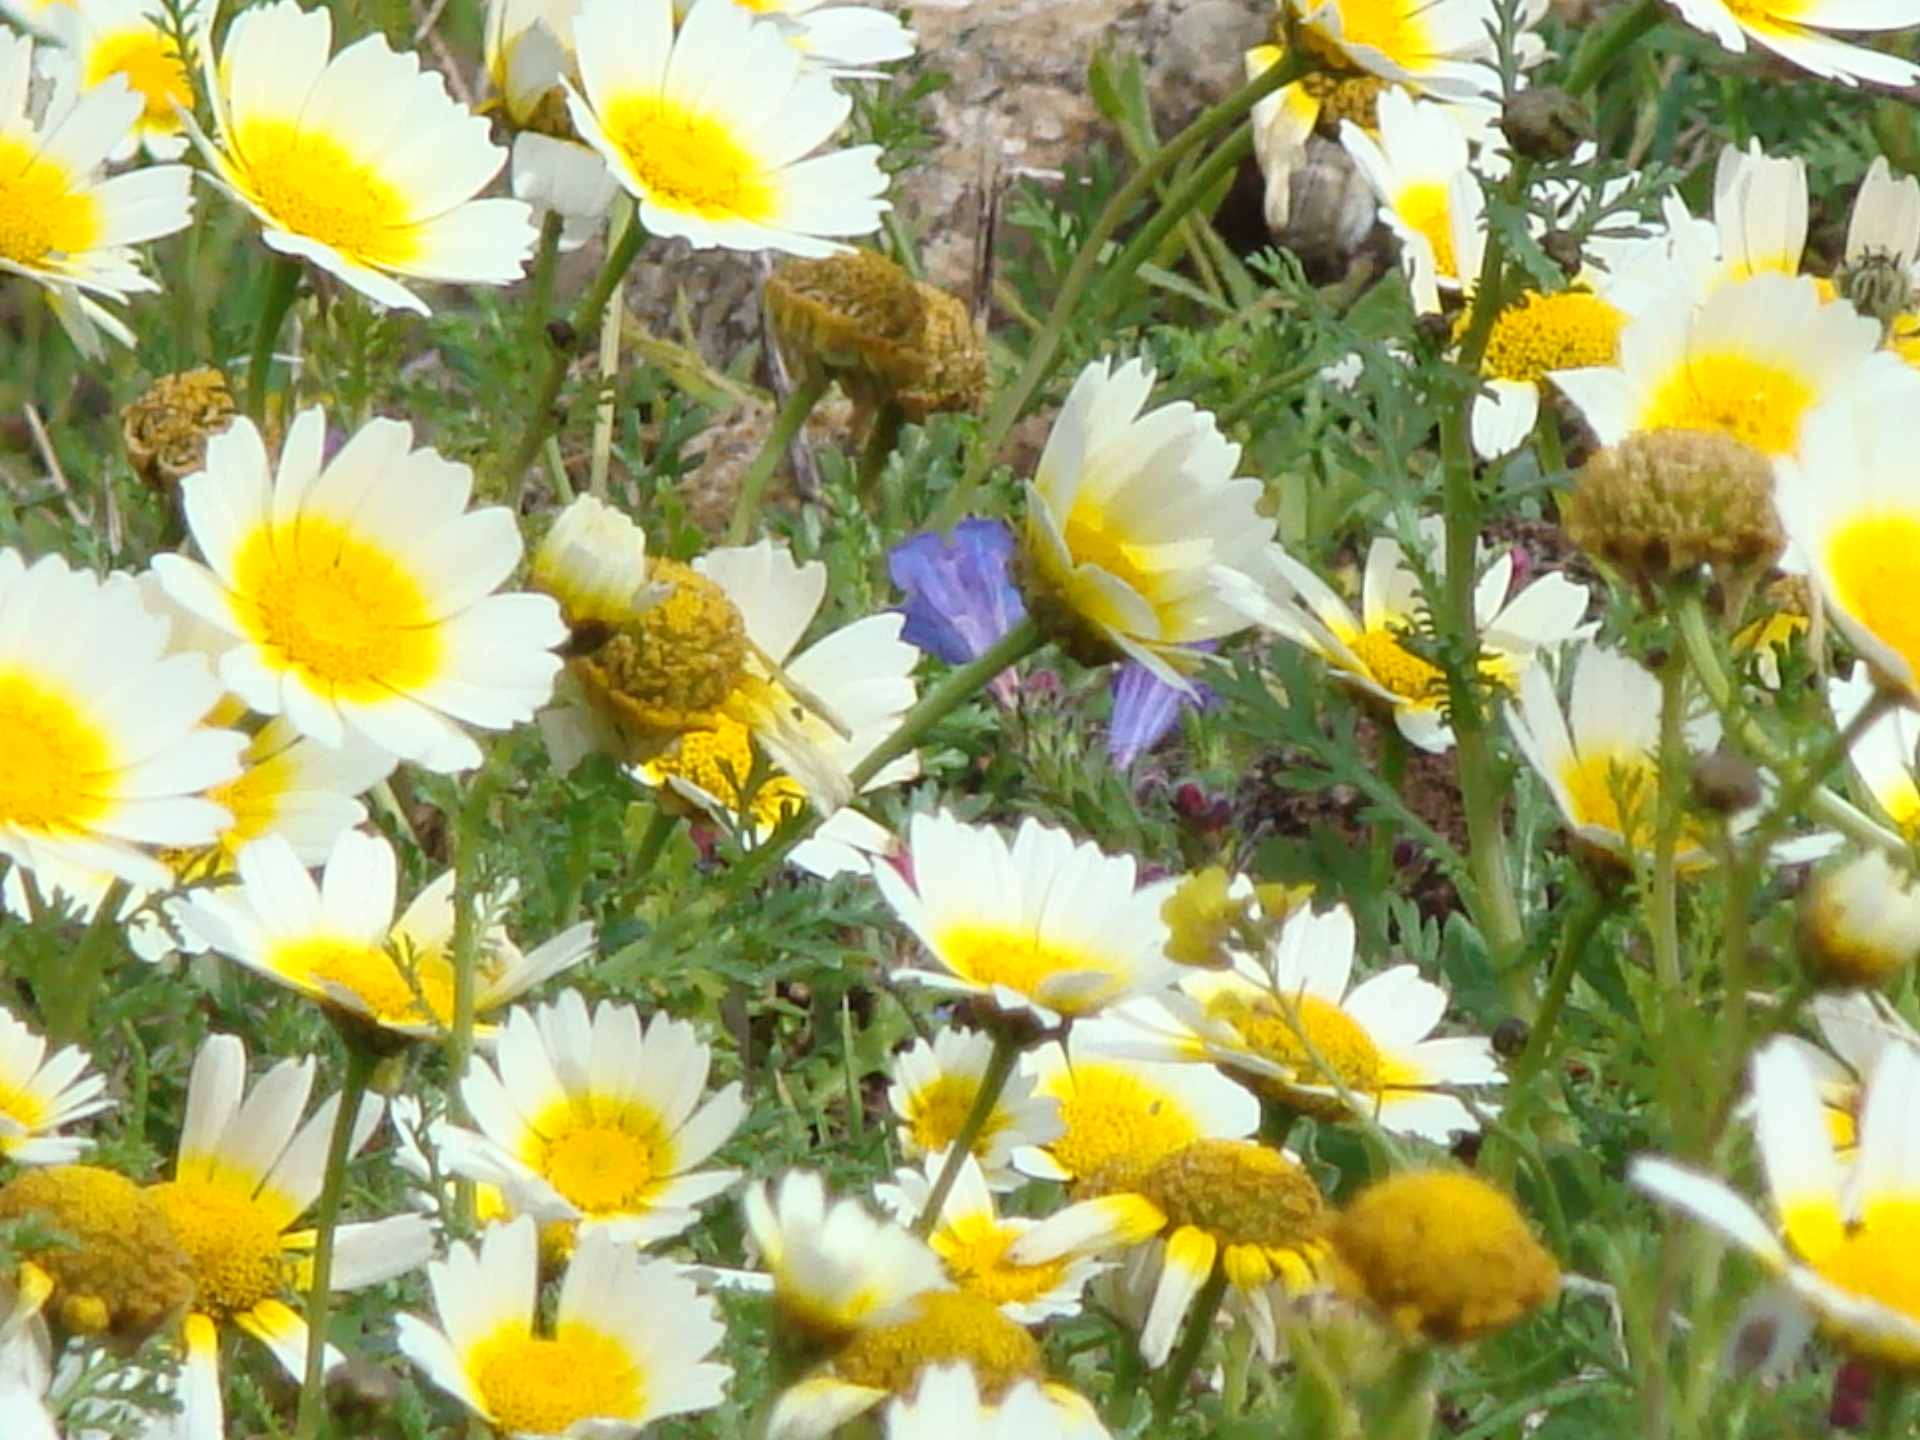
| Score | Classification Standard | | Typical Image |
| SC1 | Uniform strain over the whole hypoechoic area - like the surrounding normal tissue | | |
| SC1*<br>(RGB) | 3 color layer pattern, RED located at the posterior part – typical artifact pattern seen in a cyst | | |
| SC2 | Strain over most of the hypoechoic area with some areas spared - 3 color pattern WITHOUT a 3 layer presentation | | |
| SC3 | Strain at the periphery with the hypoechoic area spared - centre blue & periphery green (around all the peripheral part of the nodule +++) | | |
| SC4 | No strain within the entire hypoechoic area (entire blue or max of blue (fixed)) | | |
| SC5 | No strain within the hypoechoic area nor in the surrounding tissues (entire blue + outside the nodule) | | |

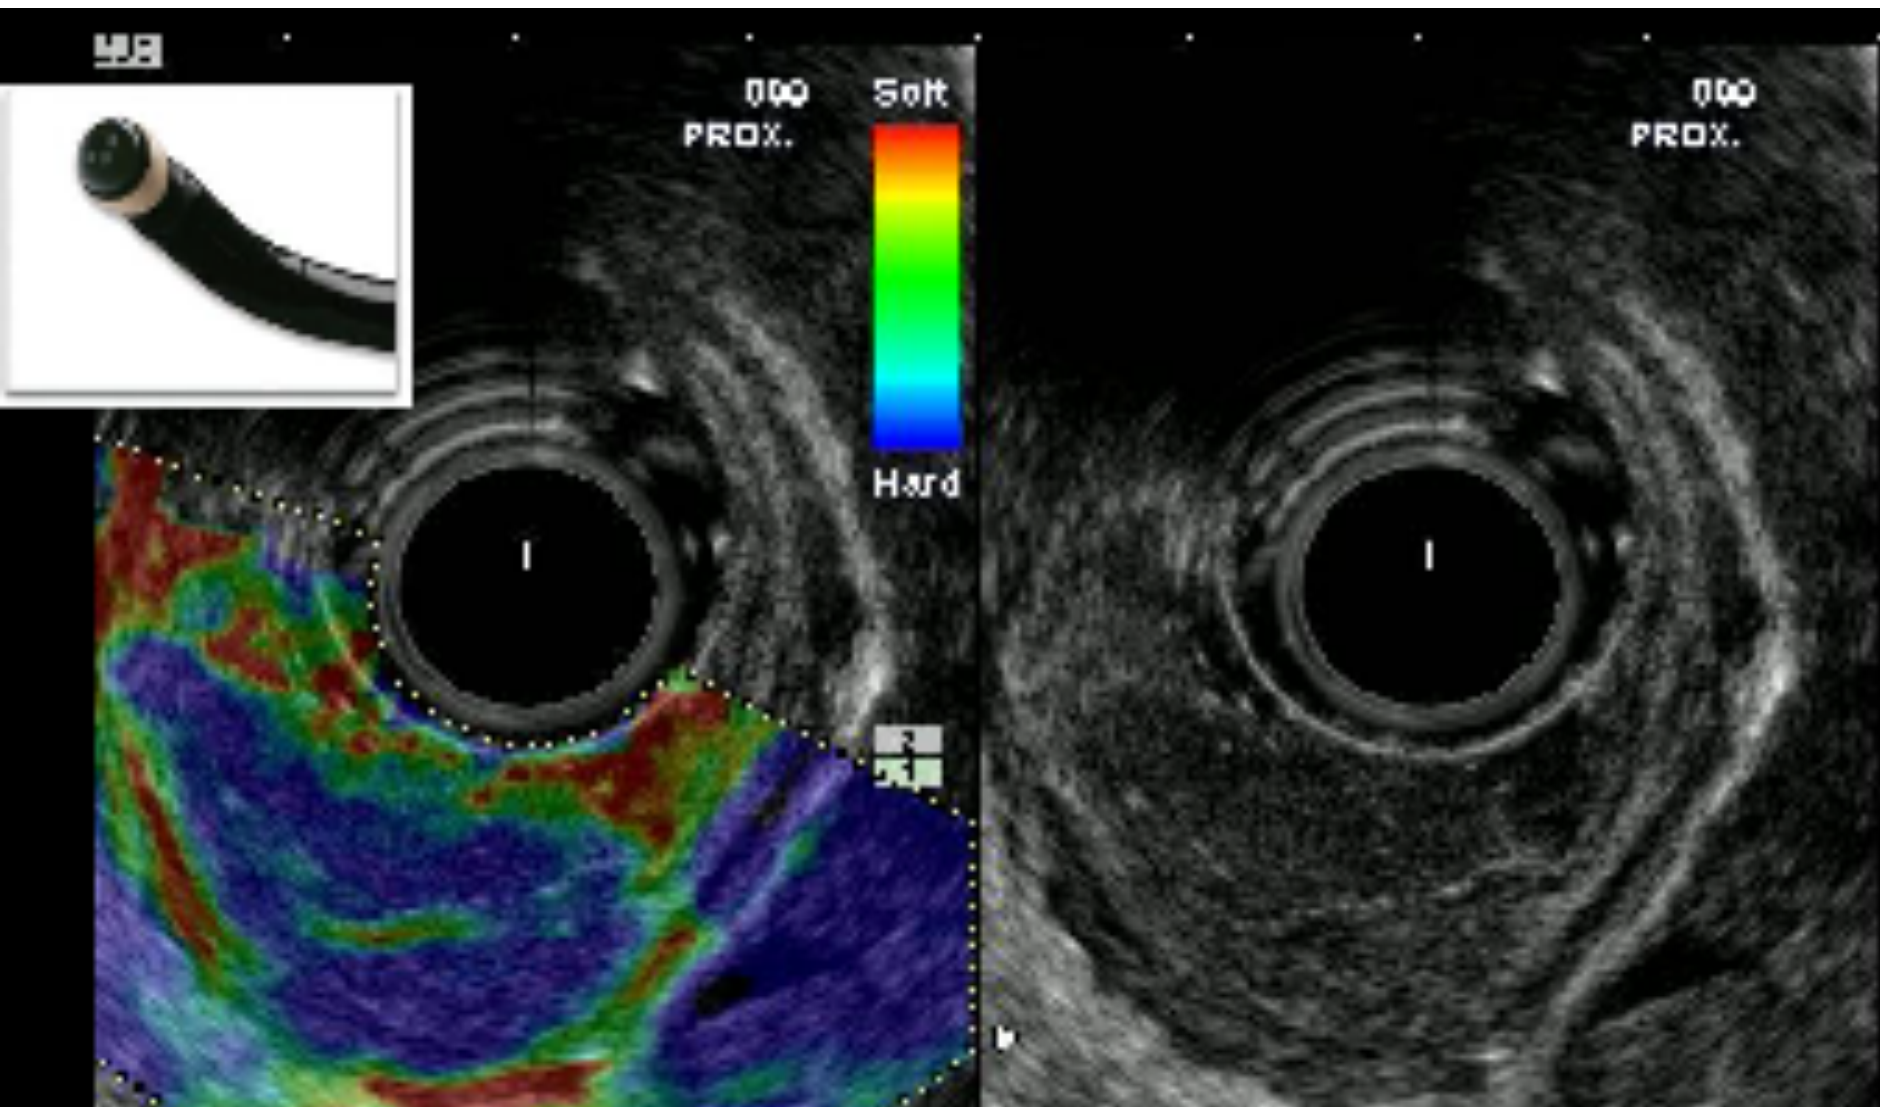
**T2 rectal tumour- 360° radial scope**

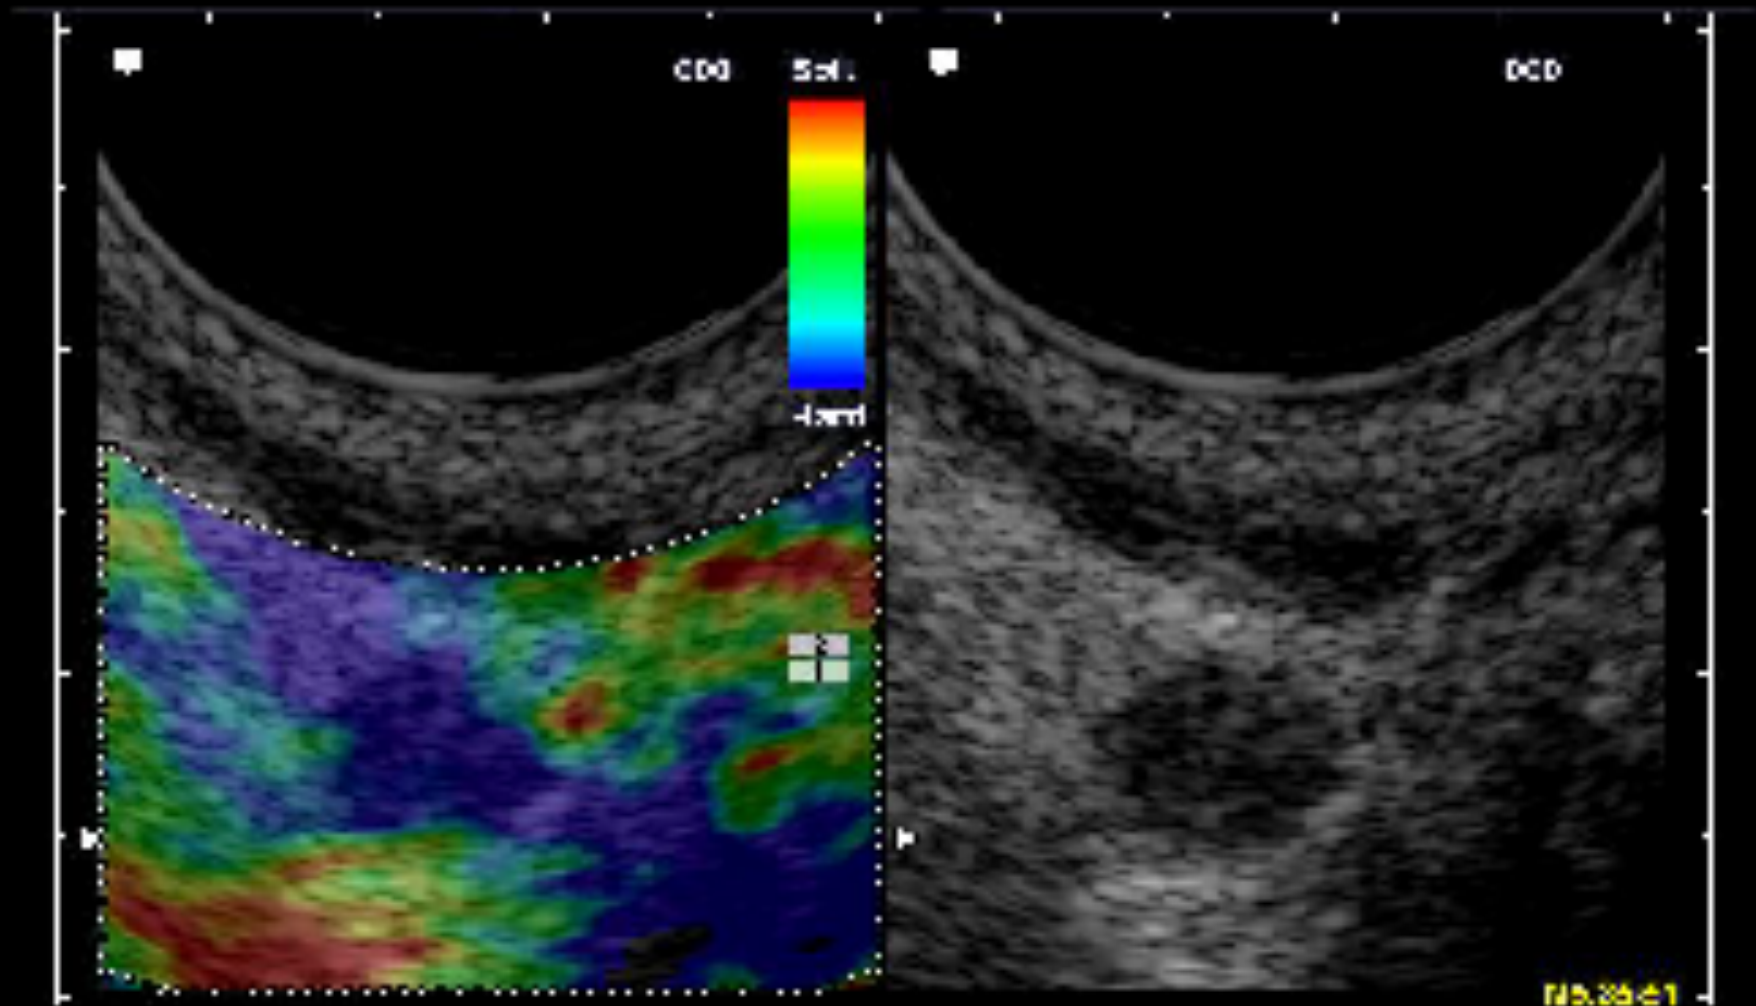
Lymph node infiltration

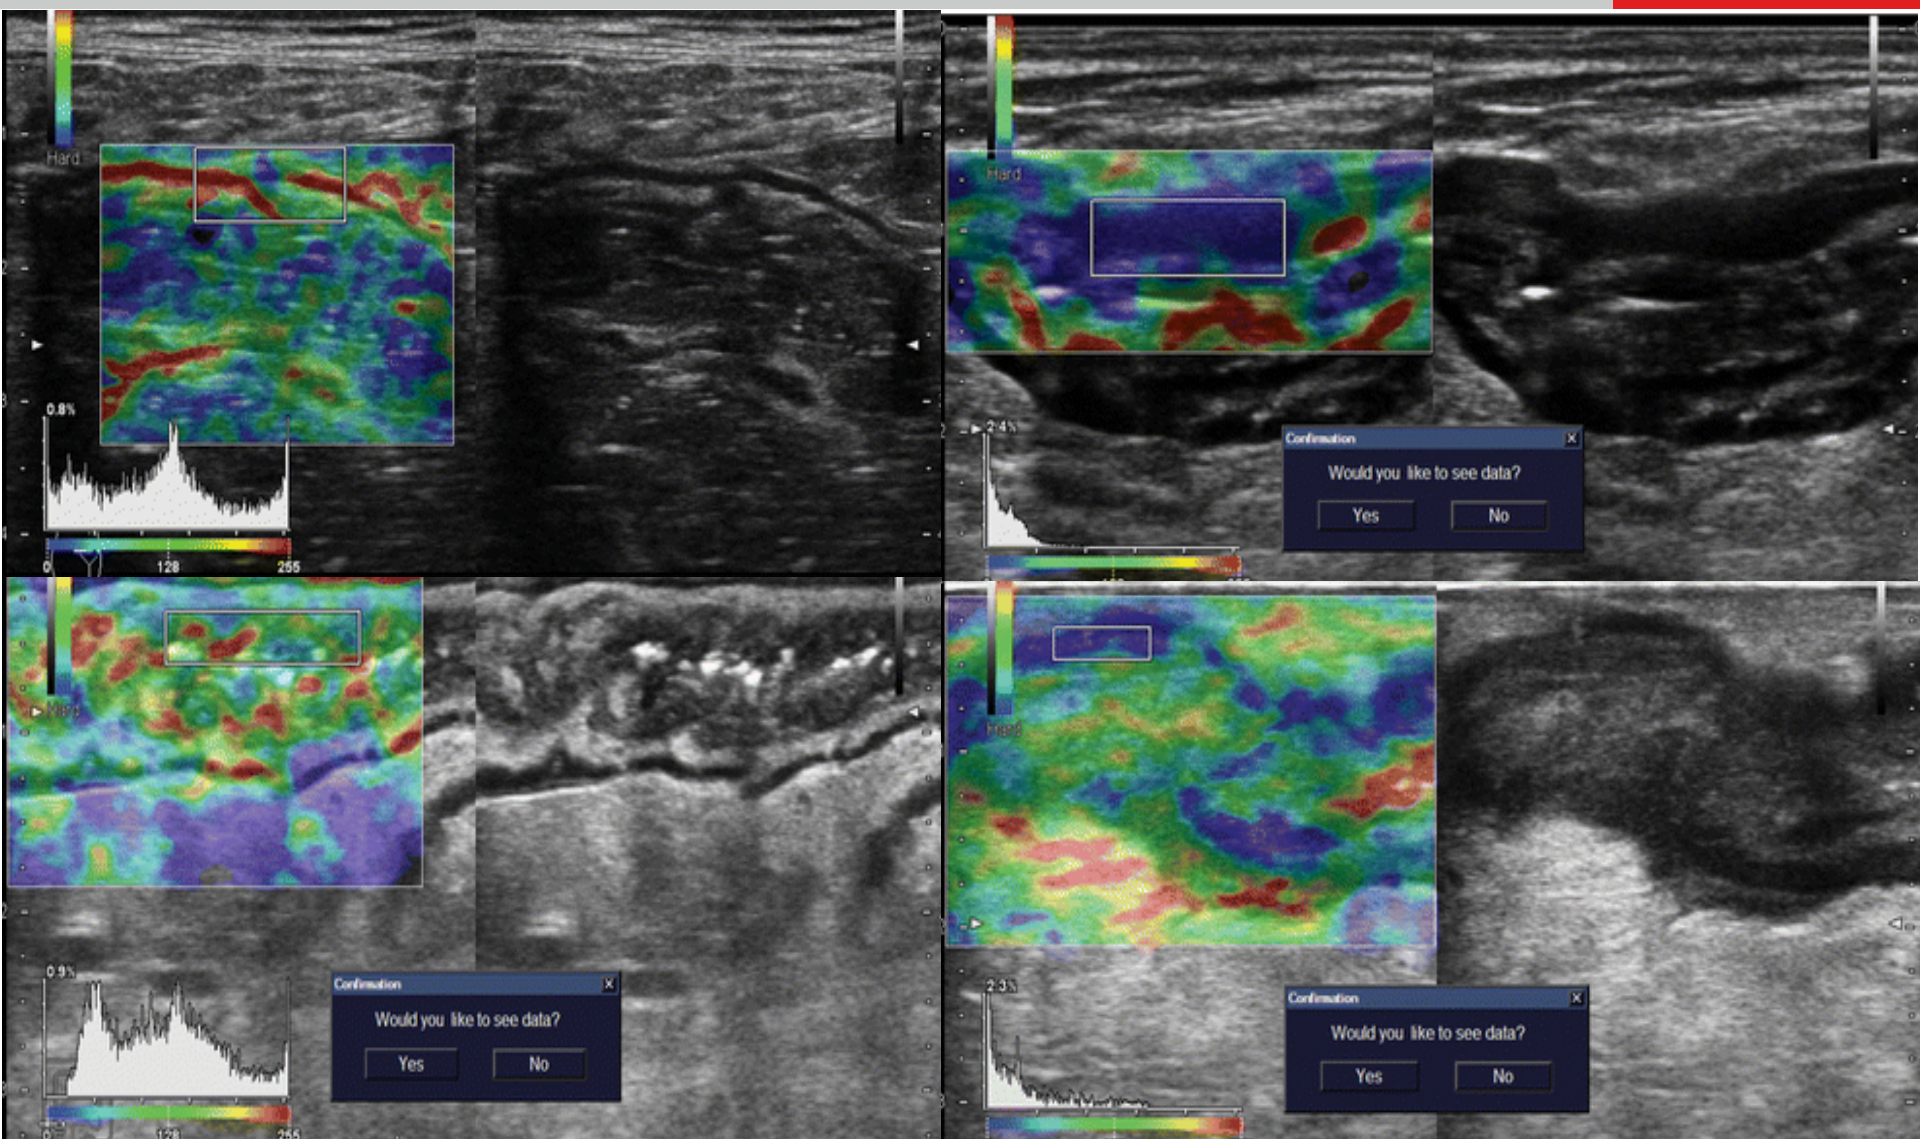
**Unaffected segment**

**Affected segment**

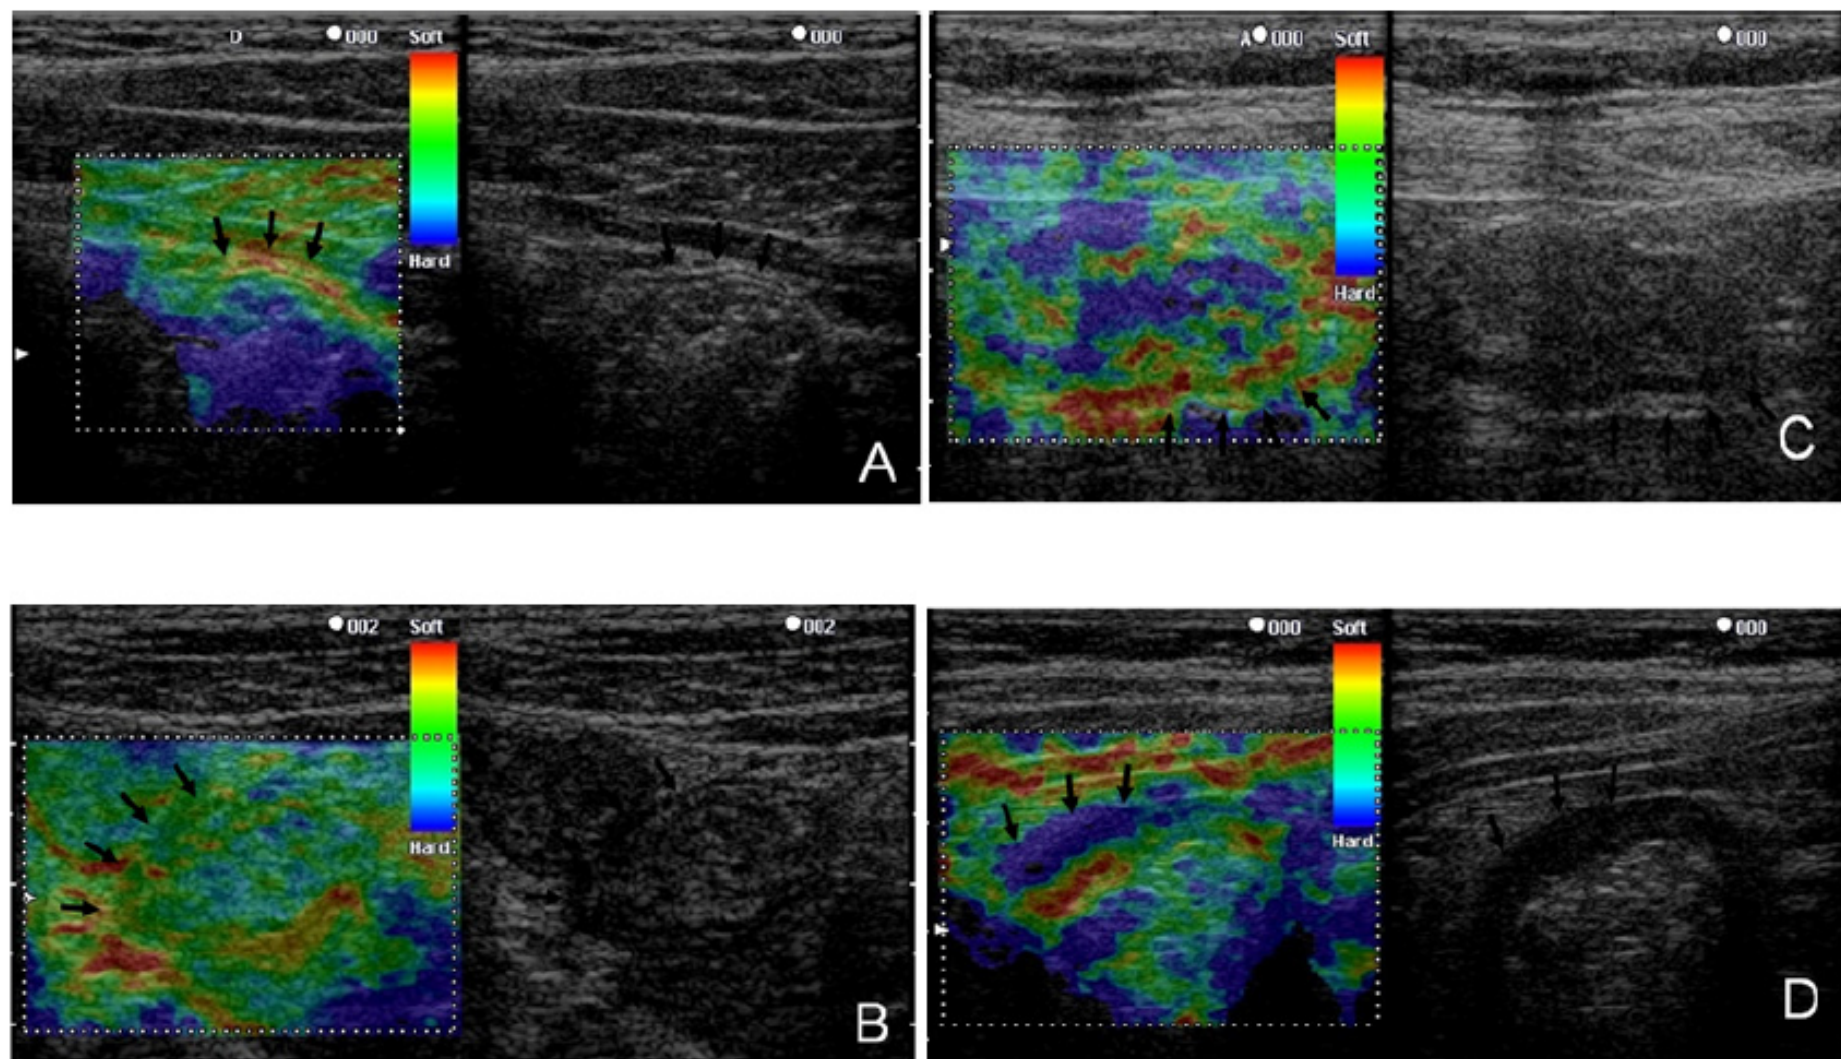
**Figure 2 Classification of elastography findings.** A: Normal type: the wall of the colon was not thickened (less than 4 mm), and the layer structure was observed in B-mode. Almost all parts of the wall appeared green in EG-mode, but the second layer was sometimes red. B: Homogeneous type: the wall was thick in B-mode but the layer structure was unclear. The thick wall was almost completely green in EG-mode. C: Random type: the wall was thick in B-mode and the layer structure was unclear. Various colors (red, green, blue) were mixed throughout the thick wall in EG-mode. D: Hard type: the wall was thick in B-mode and the layer structure was unclear. The thick wall was almost completely blue.
